**Flood Control Project Maintenance
Levee Inspections**

Maintenance Issue Types Only, Levee Inspection Report By Mile - Spring 2017

Butte County Department of Public Works

Waterway	Bank	Unit Miles	Inspection Start/End	Inspector
Unit No. 01 Mud Creek	Right	6.80	04/20/2017 04/20/2017	Bob Duffey

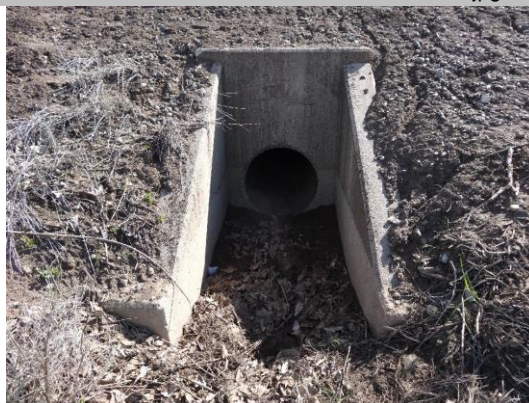
Photo 2 of 3 : UCIP_SP_2017_29705_54923.jpg

LS view: U typed concrete headwall, CMP on levee slope.

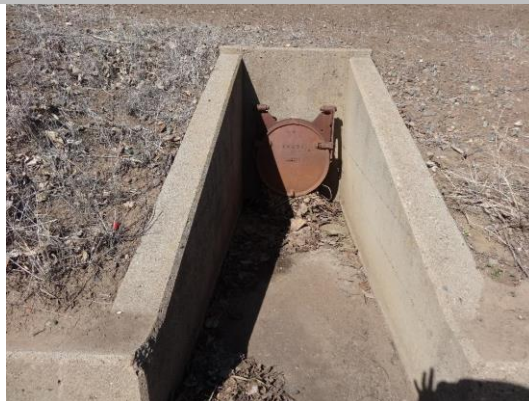
Photo 1 of 3 : UCIP_SP_2017_32044_58543.jpg

LM Start	1.00	Rating **	M	Issue No.	59
LM End	1.00	Issue Type +	Ma	Location *	N/A
Category	Supplemental			GPS Latitude/Longitude	
				Start	End
Item	DWR UCIP LMA Responsibility			39.739268 °	39.739268 °
				-121.931891 °	-121.931891 °
DWR ID					
Comment Code					
Inspector Comment					
FS_ID:32044 DS_ID:19211 EP_NO: N/A Repair Type: Non-Urgent Crossing Status: Found UCIP Comments: Vegetation debris on waterside. Needs clearing and cleaning. FIELD_STRUCT_DESC: 24-inch CM pipe through the levee, 12.0 feet below the crown. Flap gate on the waterward end. Concrete "U" headwalls on both ends. Grouted riprap apron on the landward end. Grouted riprap spillway on the waterward end. O&M Manual Sac 504, May 1965. FS Date: 2/20/2014

WS view: U typed concrete headwall, pipe, and flapgate on levee slope.

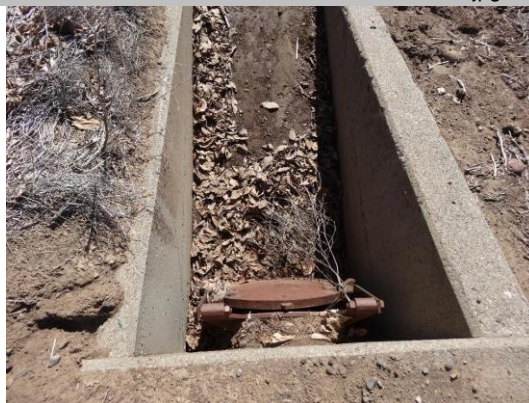
Photo 1 of 3 : UCIP_SP_2017_50142_55886.jpg

WS view: U type concrete headwall, flapgate on levee slope. Gate was not fully closed.

FS_ID:50142
DS_ID:19212
EP_NO: N/A
Repair Type: No Action Needed
Crossing Status: Found
UCIP Comments: 08/29/2016: Shawn Bates of NA0003 has cleared the LS and WS of debris and blockage; WS gate functions properly now. Crossing has been downgraded from Urgent to No Action Needed. (K. Fazel - UCIP)08/11/2016: Same as last inspection. (K. Fazel - UCIP)02/20/2014: No riprap spillway on waterside. Needs cleaning and clearing of debris. Flap gate was not fully closed. (P. Amatya - UCIP)
FIELD_STRUCT_DESC: 24-inch corrugated metal pipe through the levee, 13 feet below the crown. Flap gate on the waterside (WS) end. Concrete "U" headwalls on both ends. Grouted riprap apron on the landside (LS) end. Grouted riprap spillway on the WS end. [Additional Reference(s): DWR Levee Log, 2005. USACE Sacramento O&M Manual 504, May 1965 (HLM 1.95)].
FS Date: 8/11/2016

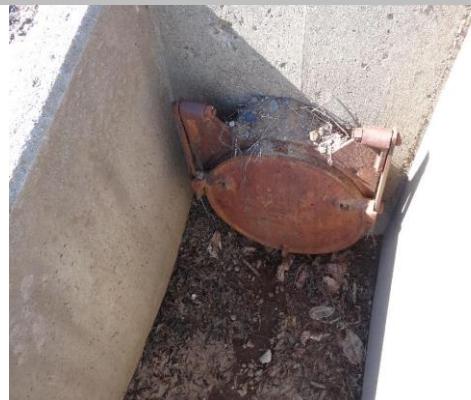
Photo 1 of 2 : UCIP_SP_2017_30294_55704.jpg

FS_ID:30294
DS_ID:19216
EP_NO: N/A
Repair Type: Non-Urgent
Crossing Status: Found
UCIP Comments: Inlet and outlet needs cleaning and clearing of debris.
FIELD_STRUCT_DESC: 24-inch CM pipe through levee, 8.5 feet below the crown. Flap gate on the waterward end. Concrete "U" headwalls on both ends. Grouted riprap apron on the landward end. Grouted riprap spillway on the waterward end. O&M Manual Sac 504, May 1965.
FS Date: 2/20/2014

WS view: U type concrete headwall, flapgate on levee slope.

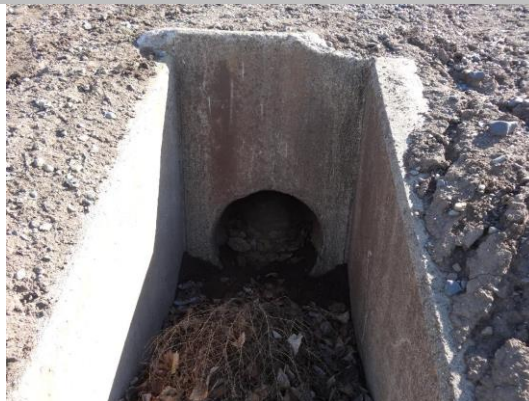
Photo 2 of 3 : UCIP_SP_2017_30310_55740.jpg

LS view: U type concrete headwall and CMP on levee slope.

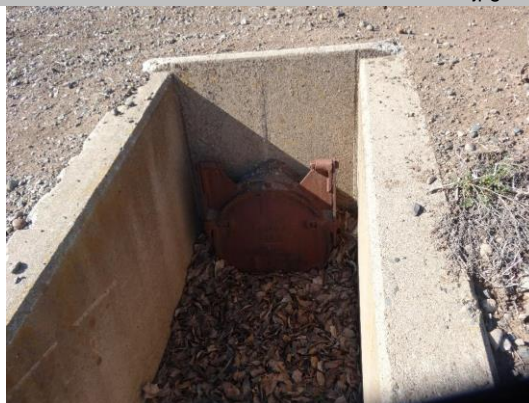
Photo 1 of 2 : UCIP_SP_2017_30311_55743.jpg

LM Start	3.97	Rating **	M	Issue No.	65
LM End	3.97	Issue Type +	Ma	Location *	LS
Category	Supplemental			GPS Latitude/Longitude	
				Start	End
Item	DWR UCIP LMA Responsibility			39.771293 °	39.771293 °
				-121.900247 °	-121.900247 °
DWR ID					
Comment Code					
Inspector Comment					
FS_ID:30311 DS_ID:19219 EP_NO: N/A Repair Type: Non-Urgent Crossing Status: Found UCIP Comments: Needs cleaning and clearing of debris in both ends of the pipe. FIELD_STRUCT_DESC: 24-inch CM pipe through the levee, 9.0 feet below the crown. Flap gate on the waterward end. Concrete "U" headwalls on both ends. Grouted riprap apron on the landward end. Grouted riprap spillway on the waterward end. O&M Manual Sac 504, May 1965. FS Date: 2/20/2014

WS view: U type concrete headwall, pipe, and flapgate on levee slope.
Vegetation debris blocking outlet.

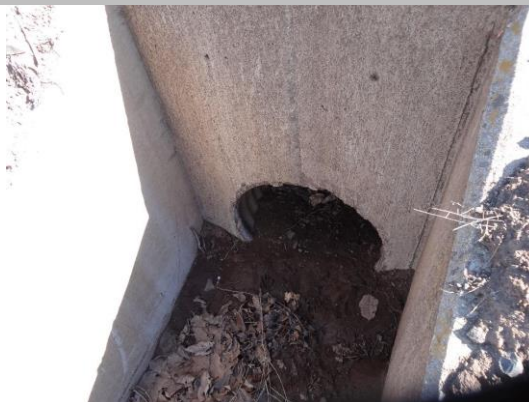
Photo 2 of 2 : UCIP_SP_2017_30311_55742.jpg

LS view: U type concrete headwall and CMP on levee slope.

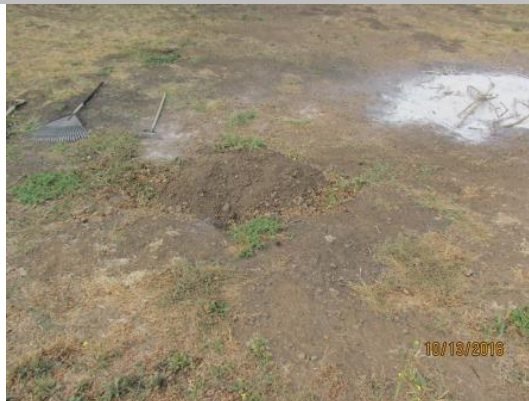
Photo 1 of 1 : SP_2017_NA0003_64_51_20170315_00030.jpg

View of the rodent holes along the landside slope.

LM Start	4.03	Rating **	M	Issue No.	51
LM End	4.03	Issue Type +	Ma	Location *	LS
Category	Earthen Levee			GPS Latitude/Longitude	
				Start	End
Item	Animal Control			39.771877 °	39.771877 °
				-121.899441 °	-121.899441 °
DWR ID	DWR_NA0003_01_f_2016_51				
Comment Code					
A1 : Exterminate rodents and backfill and compact or grout burrows.					
Inspector Comment

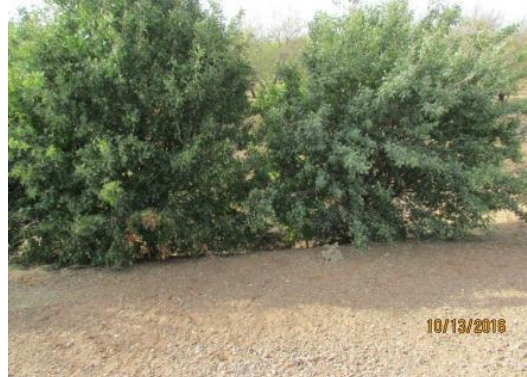
Photo 1 of 1 : SP_2017_NA0003_64_53_20170315_00032.jpg

View of the trees along the landside toe.

LM Start	4.45	Rating **	M	Issue No.	53
LM End	4.45	Issue Type +	Ma	Location *	LS
Category	Earthen Levee			GPS Latitude/Longitude	
				Start	End
Item	Trim / Thin Trees			39.775789 °	39.775789 °
				-121.894048 °	-121.894048 °
DWR ID	DWR_NA0003_01_f_2016_53				
Comment Code					
T1 : Trim trees to at least five feet above ground level.					
Inspector Comment

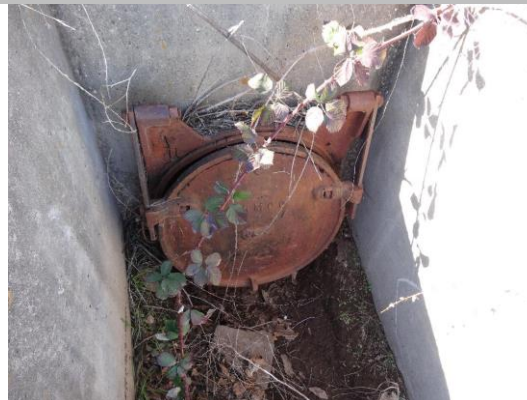
Photo 1 of 2 : UCIP_SP_2017_30312_55745.jpg

LM Start	4.46	Rating **	M	Issue No.	66
LM End	4.46	Issue Type +	Ma	Location *	LS
Category	Supplemental			GPS Latitude/Longitude	
				Start	End
Item	DWR UCIP LMA Responsibility			39.775905 °	39.775905 °
				-121.893980 °	-121.893980 °
DWR ID					
Comment Code					
Inspector Comment					
FS_ID:30312					
DS_ID:19220					
EP_NO: N/A					
Repair Type: Non-Urgent					
Crossing Status: Found					
UCIP Comments: Needs cleaning and clearing of debris.					
FIELD_STRUCT_DESC: 24-inch CM pipe through the levee, 13.0 feet below the crown. Flap gate on the waterward end. Concrete "U" headwalls on both ends. Grouted riprap apron on the landward end. Grouted riprap spillway on the waterward end. O&M Manual Sac 504, May 1965.					
FS Date: 2/20/2014

WS view: U type concrete headwall, pipe, and flapgate on levee slope.
Vegetation debris blocking outlet.

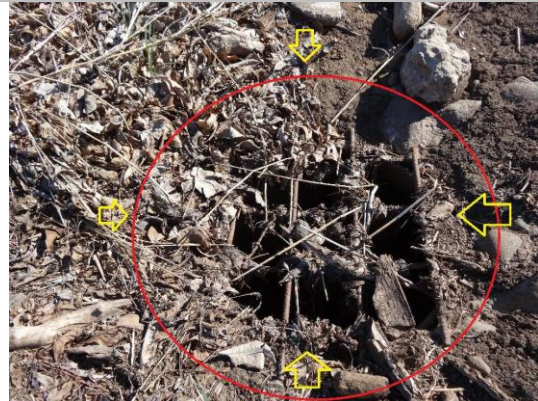
Photo 2 of 2 : UCIP_SP_2017_30388_55890.jpg

Comment Code						
Inspector Comment						
FS_ID:30388 DS_ID:19221 EP_NO: N/A Repair Type: Non-Urgent Crossing Status: Found UCIP Comments: CM Standpipe intake. Intake pipe with air vent. Steel rib-bar grit cover on the standpipe on landside levee toe.Needs cleaning and clearing on both ends of the pipe. FIELD_STRUCT_DESC: 24-inch CM pipe through the levee, 15.0 feet below the crown. Flap gate on the waterward end. Concrete "U" headwalls on waterside ends. Grouted riprap spillway on the waterward end. CM Standpipe intake. Intake pipe with air vent. Steel rib-bar grit cover on the standpipe on landside levee toe. O&M Manual Sac 504, May 1965. FS Date: 2/20/2014

LS view: Underground CM standpipe intake with steel grit on levee toe.

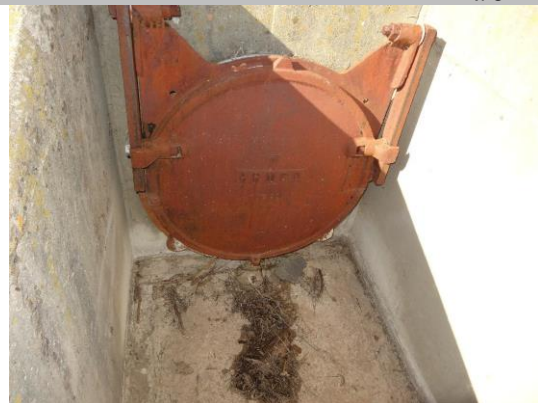
Photo 1 of 3 : UCIP_SP_2017_30327_55768.jpg

WS view: U type concrete headwall, pipe, and flapgate on levee slope.

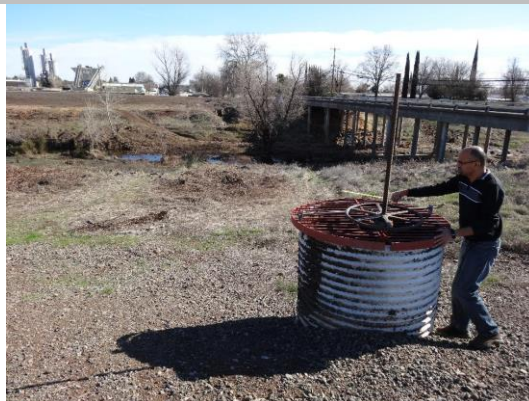
Photo 2 of 3 : UCIP_SP_2017_30327_55767.jpg

WS view: CM standpipe with slide gate on levee slope.

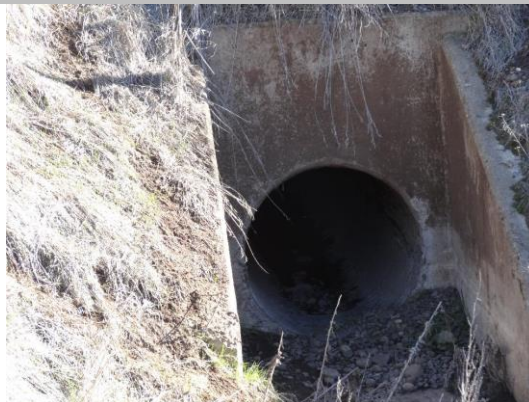
Photo 3 of 3 : UCIP_SP_2017_30327_55766.jpg

LS view: U type concrete headwall and CMP on levee slope.

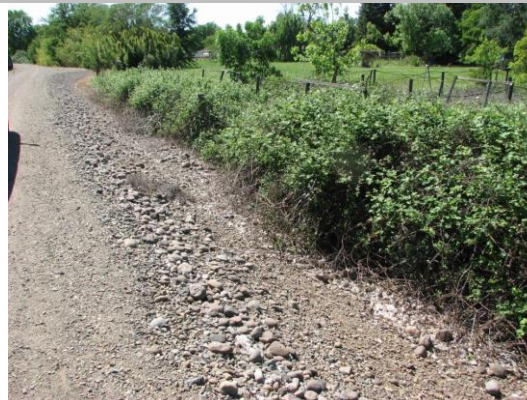
Photo 1 of 1 : SP_2017_NA0003_64_34_20170315_00017.jpg

LM Start	6.16	Rating **	M	Issue No.	34
LM End	6.16	Issue Type +	Ma	Location *	LS
Category	Earthen Levee			GPS Latitude/Longitude	
				Start	End
Item	Vegetation			39.795428 °	39.795428 °
				-121.885306 °	-121.885306 °
DWR ID	DWR_NA0003_01_s _ 2016_34				
Comment Code					
V2 : Remove the wild growth other than native grasses from the levee slopes.					
Inspector Comment					
Blackberry bramble on landside toe blocking visibility.

Trim vegetation at L/S toe.

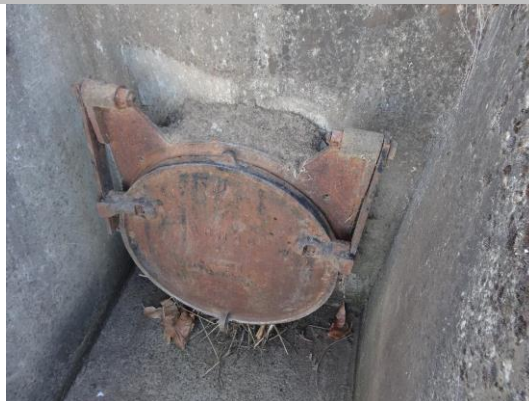
Photo 1 of 3 : UCIP_SP_2017_30403_55922.jpg

LM Start	1.26	Rating **	M	Issue No.	42
LM End	1.26	Issue Type +	Ma	Location *	LS
Category	Supplemental			GPS Latitude/Longitude	
				Start	End
Item	DWR UCIP LMA Responsibility			39.784062 °	39.784062 °
				-121.884344 °	-121.884344 °
DWR ID					
Comment Code					
Inspector Comment					
FS_ID:30403 DS_ID:19235 EP_NO: N/A Repair Type: Non-Urgent Crossing Status: Found UCIP Comments: Needs cleaning and clearing of debris. FIELD_STRUCT_DESC: 24-inch CM pipe through levee, 12.5 below the crown. Flap gate on the waterward end. Concrete "U" headwalls on both ends. Grouted riprap apron on the landward end. Grouted riprap spillway on the waterward end. O&M Manual Sac 504, May 1965. FS Date: 2/24/2014

WS view: U type concrete headwall, pipe, and flapgate on levee slope.

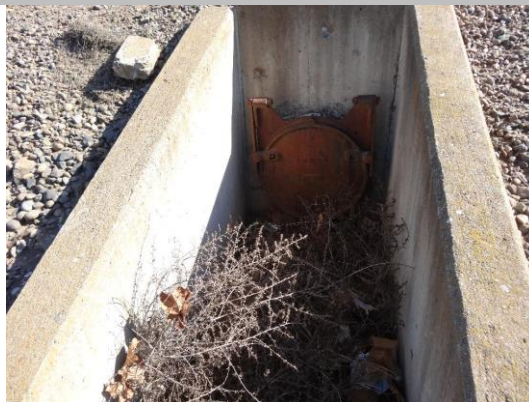
Photo 1 of 3 : UCIP_SP_2017_30763_56662.jpg

LM Start	2.34	Rating **	M	Issue No.	46
LM End	2.34	Issue Type +	Ma	Location *	LS
Category	Supplemental			GPS Latitude/Longitude	
				Start	End
Item	DWR UCIP LMA Responsibility			39.772185 °	39.772185 °
				-121.895681 °	-121.895681 °
DWR ID					
Comment Code					
Inspector Comment					
FS_ID:30763 DS_ID:19239 EP_NO: N/A Repair Type: Non-Urgent Crossing Status: Found UCIP Comments: Debris in landside inlet area. Needs cleaning and clearing of debris. FIELD_STRUCT_DESC: 24-inch CM pipe through the levee, 10.0 feet below the crown. Flap gate on the waterward end. Concrete "U" headwalls on both ends. Grouted riprap apron on the landward end. Grouted riprap spillway on the waterward end. O&M Manual Sac 504, May 1965. FS Date: 2/24/2014

WS view: U type concrete headwall, pipe, and flapgate on levee slope.
Vegetation debris blocking outlet.

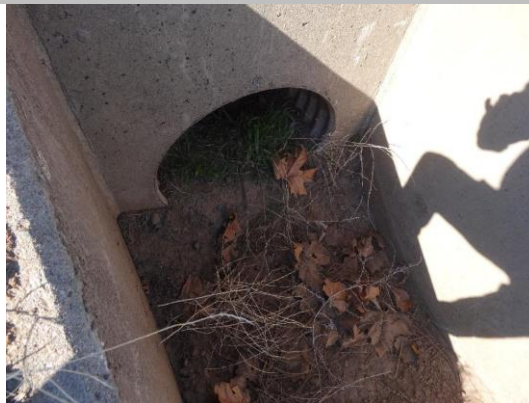
Photo 2 of 3 : UCIP_SP_2017_30763_56661.jpg

LS view: U type concrete headwall and CMP on levee slope.

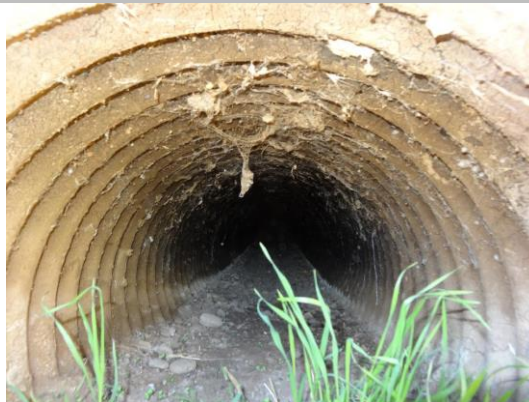
Photo 3 of 3 : UCIP_SP_2017_30763_56660.jpg

LS view: inside view of CMP on levee slope. Needs cleaning and clearing.

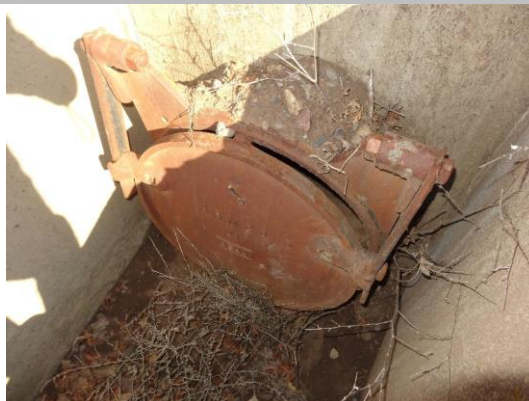
Photo 1 of 3 : UCIP_SP_2017_30783_56682.jpg

WS view: U type concrete headwall, pipe, and flapgate on levee slope.
Gate not fully closed. Debris and soil in outlet box.

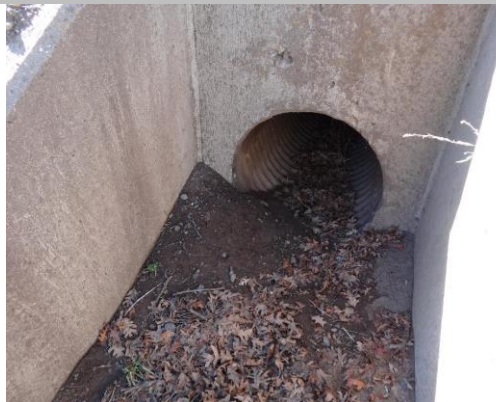
Photo 2 of 3 : UCIP_SP_2017_30783_56681.jpg

LS view: U type concrete headwall and CMP on levee slope. Debris and soil in inlet box.

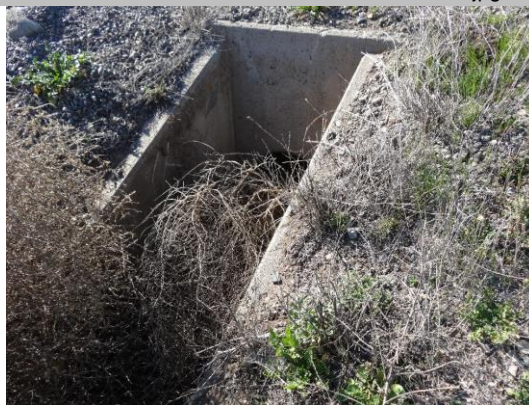
Photo 2 of 3 : UCIP_SP_2017_30803_56684.jpg

LS view: U type concrete headwall and CMP on levee slope. Vegetation debris and soil blocking inlet.

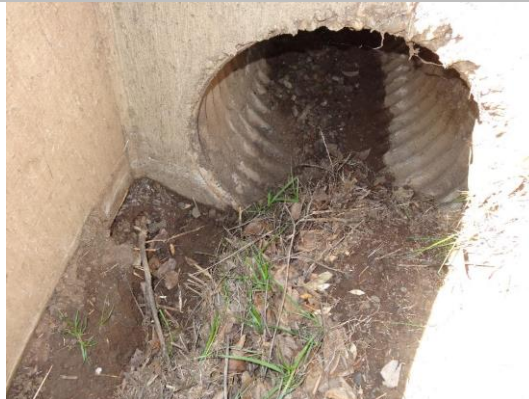
Photo 2 of 3 : UCIP_SP_2017_31028_56912.jpg

LS view: U type concrete headwall and CMP on levee slope.

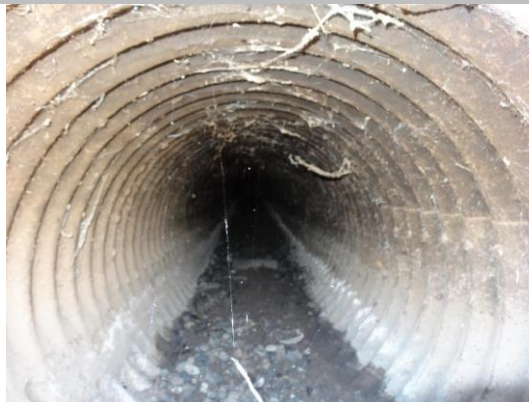
Photo 3 of 3 : UCIP_SP_2017_31028_56911.jpg

LS view: inside view of CMP on levee slope. Needs cleaning and clearing.

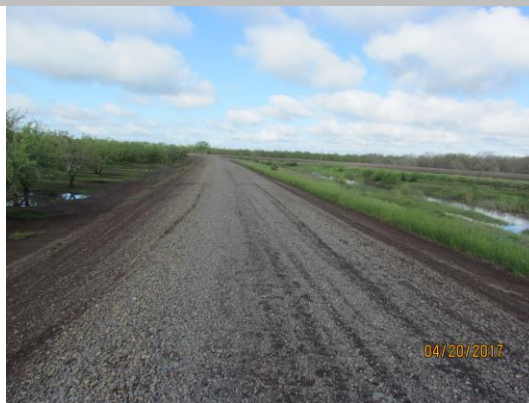
Photo 1 of 1 : SP_2017_NA0003_65_28_20170426_00025.jpg

View of no vegetation on both slopes.

LM Start	5.56	Rating **	A	Issue No.	28
LM End	5.56	Issue Type +	Ma	Location *	LS
Category	Earthen Levee			GPS Latitude/Longitude	
				Start	End
Item	Vegetation			39.739085 °	39.739085 °
				-121.928878 °	-121.928878 °
DWR ID	DWR_NA0003_02_s_2017_28				
Comment Code					
V1 : Control annual grass and weeds on the levee slopes and easements.					
Inspector Comment

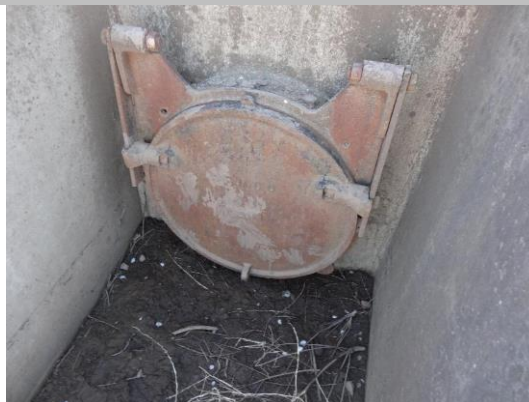
Photo 1 of 3 : UCIP_SP_2017_31031_56917.jpg

LM Start	5.64	Rating **	M	Issue No.	50
LM End	5.64	Issue Type +	Ma	Location *	LS
Category	Supplemental			GPS Latitude/Longitude	
				Start	End
Item	DWR UCIP LMA Responsibility			39.738898 °	39.738898 °
				-121.930242 °	-121.930242 °
DWR ID					
Comment Code					
Inspector Comment					
FS_ID:31031					
DS_ID:19247					
EP_NO: N/A					
Repair Type: Non-Urgent					
Crossing Status: Found					
UCIP Comments: Needs cleaning and clearing of debris.					
FIELD_STRUCT_DESC: 24-inch CM pipe through the levee, 11.5 feet below the crown. Flap gate on the waterward end. Concrete "U" headwalls on both ends. Grouted riprap apron on the landward end. Grouted riprap spillway on the waterward end. O&M Manual Sac 504, May 1965.					
FS Date: 2/25/2014

WS view: U type concrete headwall, pipe, and flapgate on levee slope.
Soil/mud on outlet box.

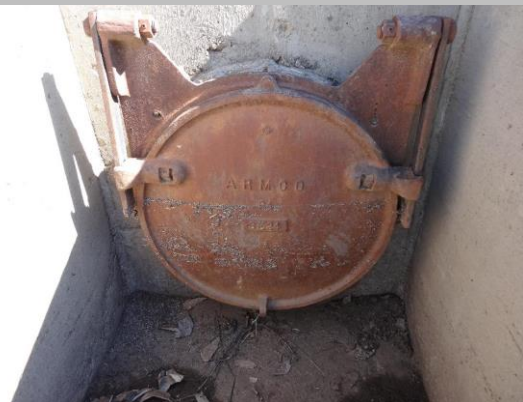
Photo 1 of 3 : UCIP_SP_2017_31034_56926.jpg

LM Start	6.15	Rating **	M	Issue No.	53
LM End	6.15	Issue Type +	Ma	Location *	LS
Category	Supplemental			GPS Latitude/Longitude	
				Start	End
Item	DWR UCIP LMA Responsibility			39.732515 °	39.732515 °
				-121.930373 °	-121.930373 °
DWR ID					
Comment Code					
Inspector Comment					
FS_ID:31034					
DS_ID:19249					
EP_NO: N/A					
Repair Type: Non-Urgent					
Crossing Status: Found					
UCIP Comments: Needs cleaning and clearing of debris.					
FIELD_STRUCT_DESC: 24-inch CM pipe through the levee, 12.0 feet below the crown. Flap gate on the waterward end. Concrete "U" headwalls on both ends. Grouted riprap apron on the landward end. Grouted riprap spillway on the waterward end. O&M Manual Sac 504, May 1965.					
FS Date: 2/25/2014

WS view: U type concrete headwall, pipe, and flapgate on levee slope.

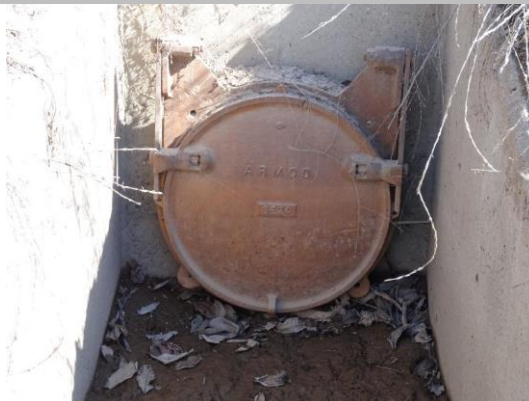
Photo 1 of 3 : UCIP_SP_2017_31085_56988.jpg

LM Start	6.43	Rating **	M	Issue No.	54
LM End	6.43	Issue Type +	Ma	Location *	LS
Category	Supplemental			GPS Latitude/Longitude	
				Start	End
Item	DWR UCIP LMA Responsibility			39.728812 °	39.728812 °
				-121.932623 °	-121.932623 °
DWR ID					
Comment Code					
Inspector Comment					
FS_ID:31085					
DS_ID:19251					
EP_NO: N/A					
Repair Type: Non-Urgent					
Crossing Status: Found					
UCIP Comments: Needs cleaning and clearing of debris.					
FIELD_STRUCT_DESC: 24-inch CM pipe through the levee, 15.5 feet below the crown. Flap gate on the waterward end. Concrete "U" headwalls on both ends. Grouted riprap apron on the landward end. Grouted riprap spillway on the waterward end. O&M Manual Sac 504, May 1965.					
FS Date: 2/25/2014

WS view: U type concrete headwall, pipe, and flapgate on levee slope.
Soil/mud on outlet box.

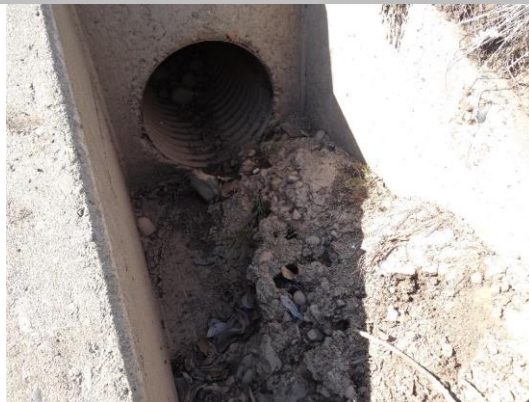
Photo 2 of 3 : UCIP_SP_2017_31085_56987.jpg

LS view: U type concrete headwall and CMP on levee slope. Soil/mud on inlet box.

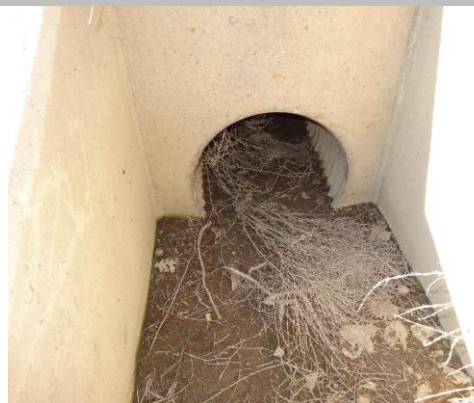
Photo 2 of 3 : UCIP_SP_2017_31103_57001.jpg

LM Start	6.94	Rating **	M	Issue No.	55 (cont)	
LM End	6.94	Issue Type +	Ma	Location *	LS	
Category	Supplemental			GPS Latitude/Longitude		
				Start	End	
Item	DWR UCIP LMA Responsibility			39.722798 °	39.722798 °	
				-121.937828 °	-121.937828 °	
DWR ID						
Comment Code						
Inspector Comment						
FS_ID:31103						
DS_ID:19252						
EP_NO: N/A						
Repair Type: Non-Urgent						
Crossing Status: Found						
UCIP Comments: Needs cleaning and clearing of debris.						
FIELD_STRUCT_DESC: 24-inch CM pipe through the levee, 15.0 feet below the crown. Flap gate on the waterward end. Concrete "U" headwalls on both ends. Grouted riprap apron on the landward end. Grouted riprap spillway on the waterward end. O&M Manual Sac 504, May 1965.						
FS Date: 2/25/2014

LS view: U type concrete headwall and CMP on levee slope. Soil/mud on inlet box.

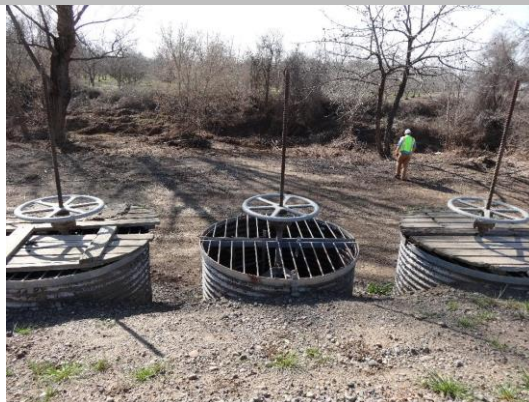
Photo 1 of 3 : UCIP_SP_2017_32085_58585.jpg

LM Start	7.22	Rating **	M	Issue No.	56
LM End	7.22	Issue Type +	Ma	Location *	LS
Category	Supplemental			GPS Latitude/Longitude	
				Start	End
Item	DWR UCIP LMA Responsibility			39.718882 °	39.718882 °
				-121.937602 °	-121.937602 °
DWR ID					
Comment Code					
Inspector Comment					
FS_ID:32085 DS_ID:19253 EP_NO: N/A Repair Type: Non-Urgent Crossing Status: Found UCIP Comments: Slide gates in CMP risers on waterside shoulder.Needs cleaning and clearing of debris. FIELD_STRUCT_DESC: 1 of 3: Three 48-inch CM pipes through levee, 18.0 feet below crown. Flap gate on the waterward end. Slide gate in CMP riser on waterside shoulder. Concrete "U" headwalls on both ends. Grouted riprap apron on the landward end. Grouted riprap spillway on the waterward end. O&M Manual Sac 504, May 1965. FS Date: 2/25/2014

WS view: slide gates in CMP risers on waterside shoulder.

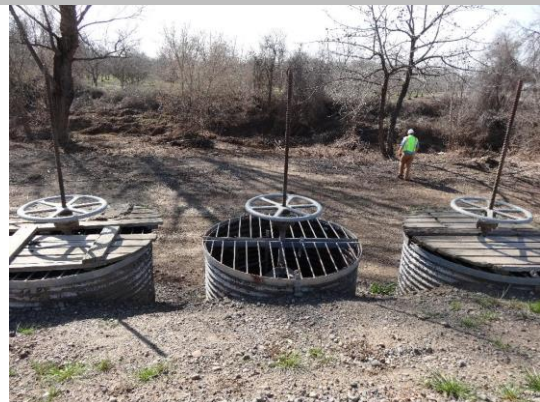
Photo 1 of 3 : UCIP_SP_2017_32086_58589.jpg

LM Start	7.23	Rating **	M	Issue No.	58
LM End	7.23	Issue Type +	Ma	Location *	LS
Category	Supplemental			GPS Latitude/Longitude	
				Start	End
Item	DWR UCIP LMA Responsibility			39.718862 °	39.718862 °
				-121.937594 °	-121.937594 °
DWR ID					
Comment Code					
Inspector Comment					
FS_ID:32086 DS_ID:19260 EP_NO: N/A Repair Type: Non-Urgent Crossing Status: Found UCIP Comments: Slide gates in CMP risers on waterside shoulder.Needs cleaning and clearing of debris. FIELD_STRUCT_DESC: 2 of 3: Three 48-inch CM pipes through levee, 18.0 feet below crown Flap gate on the waterward end. Concrete "U" headwalls on both ends. Grouted riprap apron on the landward end. Grouted riprap spillway on the waterward end. O&M Manual Sac 504, May 1965. FS Date: 2/25/2014

WS view: slide gates in CMP risers on waterside shoulder.

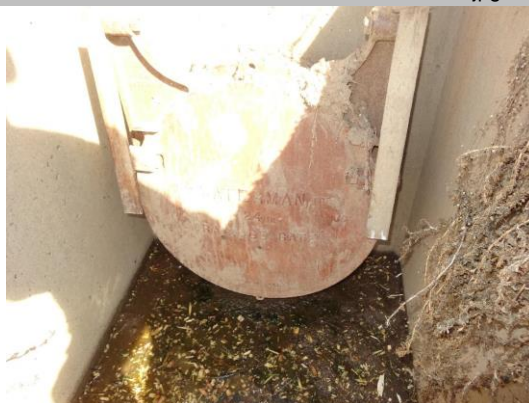
Photo 1 of 2 : UCIP_SP_2017_31129_57036.jpg

LM Start	7.77	Rating **	M	Issue No.	59
LM End	7.77	Issue Type +	Ma	Location *	LS
Category	Supplemental			GPS Latitude/Longitude	
				Start	End
Item	DWR UCIP LMA Responsibility			39.711436 °	39.711436 °
				-121.937135 °	-121.937135 °
DWR ID					
Comment Code					
Inspector Comment					
FS_ID:31129					
DS_ID:19254					
EP_NO: N/A					
Repair Type: Non-Urgent					
Crossing Status: Found					
UCIP Comments: Debris in inlet pipe, needs cleaning and clearing.					
FIELD_STRUCT_DESC: 24-inch CM pipe through the levee, 18.0 feet below the crown. Flap gate on the waterward end. Concrete "U" headwalls on both ends. Grouted riprap apron on the landward end. Grouted riprap spillway on the waterward end. O&M Manual Sac 504, May 1965.					
FS Date: 2/25/2014

WS view: U type concrete headwall, pipe, and flapgate on levee slope.
Soil/mud on outlet box.

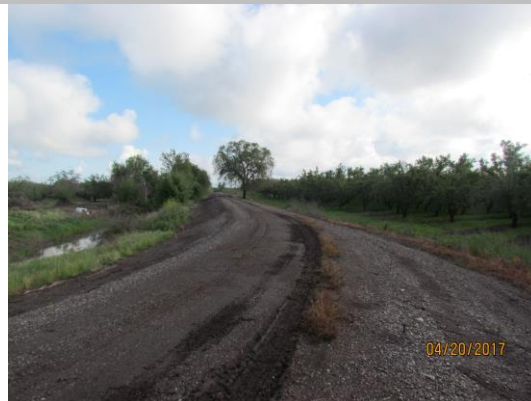
Photo 1 of 1 : SP_2017_NA0003_66_3_20170426_00001.jpg

LM Start	0.01	Rating **	A	Issue No.	3
LM End	0.01	Issue Type +	Ma	Location *	LS
Category	Earthen Levee			GPS Latitude/Longitude	
				Start	End
Item	Vegetation			39.733098 °	39.733098 °
				-121.930138 °	-121.930138 °
DWR ID	DWR_NA0003_02A_s_2017_3				
Comment Code					
V1 : Control annual grass and weeds on the levee slopes and easements.					
Inspector Comment

View of no vegetation on both slopes.

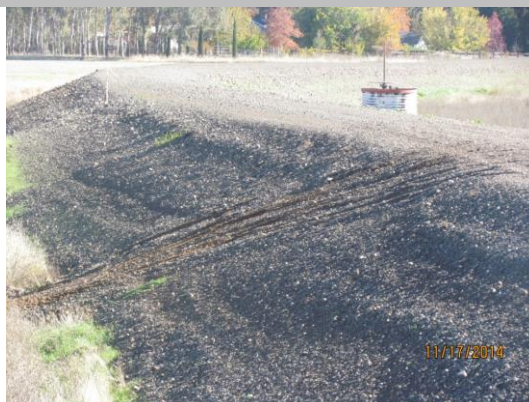
Photo 1 of 1 : SP_2017_NA0003_67_3_20170315_00001.jpg

LM Start	0.07	Rating **	M	Issue No.	3
LM End	0.07	Issue Type +	Ma	Location *	WS
Category	Earthen Levee			GPS Latitude/Longitude	
				Start	End
Item	Slope Stability			39.786068 °	39.786068 °
				-121.881828 °	-121.881828 °
DWR ID	DWR_NA0003_03_s_2012_3				
Comment Code					
S3 : Repair the levee slope damaged by vehicle traffic and prevent access where possible.					
Inspector Comment					
Repair the erosion on landside slope caused by motorcycle traffic.

View of the erosion caused by motorcycles on the land side slope.

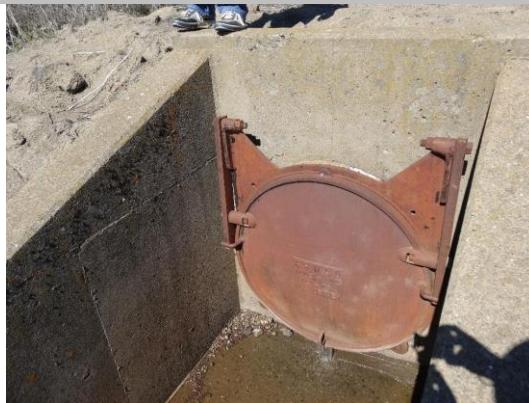
Photo 1 of 3 : UCIP_SP_2017_51844_58602.jpg

FS_ID:51844
DS_ID:19262
EP_NO: N/A
Repair Type: No Action Needed
Crossing Status: Found
UCIP Comments: 05/16/2017 Crossing has been downgraded from Non-Urgent to No Action Needed. The flap gate appears to be in good working order based on the photos, and the small pile of debris not enough to warrant Non-Urgent rating. (K. Fazel - UCIP)03/11/2014:Slide gate in CMP riser on waterside.The culvert was working during field inspection. (P. Amatya - DWR)
FIELD_STRUCT_DESC: 42-inch CM pipe through the levee, 14 feet below the crown. Flap gate on the waterward end. Slid gate in CM riser on the waterward slope. Concrete "U" headwalls on both ends. Grouted riprap apron on the landward end. Grouted riprap spillway on the waterward end. O&M Manual Sac 504, May 1965.
FS Date: 3/11/2014

WS view: U type concrete headwall, pipe, and flapgate on levee slope.

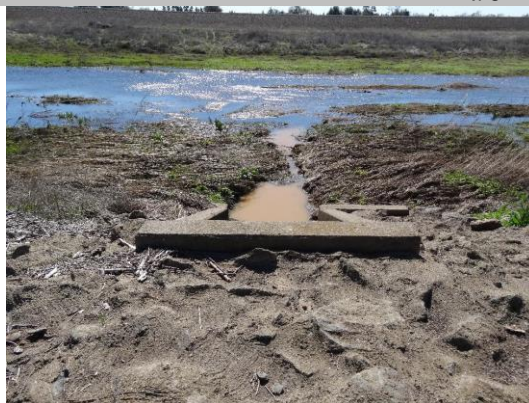
Photo 2 of 3 : UCIP_SP_2017_51844_58601.jpg

WS view: U type concrete headwall of CMP culvert on levee slope.
Grouted riprap levee slope and spillway.

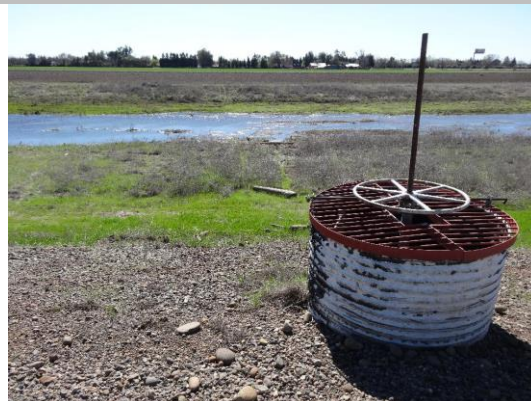
Photo 3 of 3 : UCIP_SP_2017_51844_58600.jpg

WS view: slide gate in CMP riser on waterside shoulder.

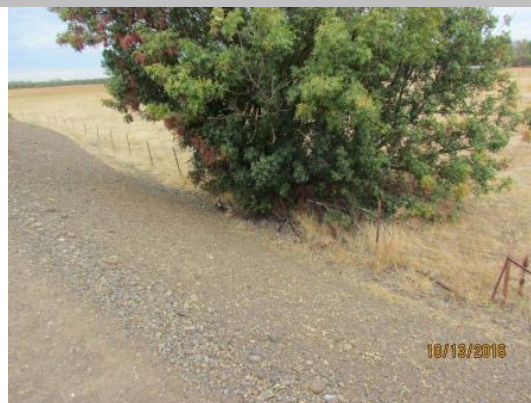
Photo 1 of 1 : SP_2017_NA0003_67_15_20170315_00004.jpg

LM Start	0.35	Rating **	M	Issue No.	15
LM End	0.35	Issue Type +	Ma	Location *	LS
Category	Earthen Levee			GPS Latitude/Longitude	
				Start	End
Item	Trim / Thin Trees			39.785704 °	39.785704 °
				-121.877004 °	-121.877004 °
DWR ID	DWR_NA0003_03_f_2016_15				
Comment Code					
T1 : Trim trees to at least five feet above ground level.					
Inspector Comment

View of the overgrown tree along the landside slope.

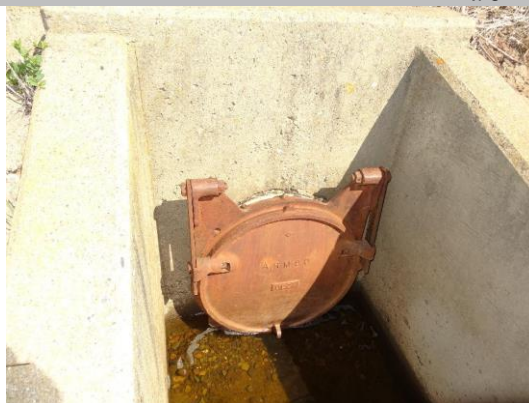
Photo 2 of 3 : UCIP_SP_2017_32107_58612.jpg

WS view: U type concrete headwall, flapgate, and CMP on levee slope.

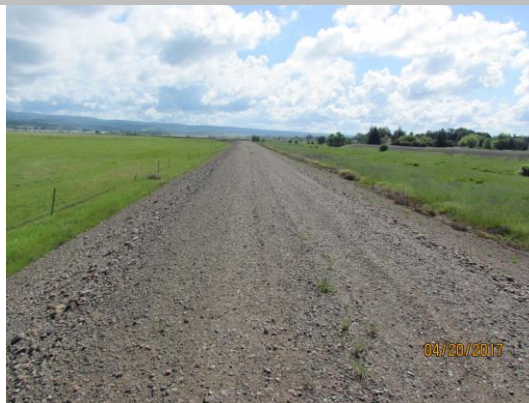
Photo 1 of 1 : SP_2017_NA0003_67_22_20170426_00038.jpg

LM Start	1.35	Rating **	A	Issue No.	22
LM End	1.35	Issue Type +	Ma	Location *	LS
Category	Earthen Levee			GPS Latitude/Longitude	
				Start	End
Item	Vegetation			39.779442 °	39.779442 °
				-121.860913 °	-121.860913 °
DWR ID	DWR_NA0003_03_s_2017_22				
Comment Code					
V1 : Control annual grass and weeds on the levee slopes and easements.					
Inspector Comment

View of no vegetation on both slopes.

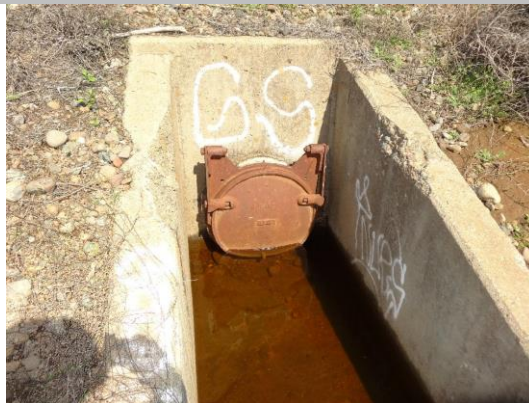
Photo 1 of 2 : UCIP_SP_2017_31899_58187.jpg

LM Start	1.50	Rating **	A/W	Issue No.	28
LM End	1.50	Issue Type +	Ma	Location *	LS
Category	Supplemental			GPS Latitude/Longitude	
				Start	End
Item	DWR UCIP LMA Responsibility			39.779230 °	39.779230 °
				-121.857945 °	-121.857945 °
DWR ID					
Comment Code					
Inspector Comment					
FS_ID:31899 DS_ID:19265 EP_NO: N/A Repair Type: No Action Needed Crossing Status: Found UCIP Comments: Working during the field visit. FIELD_STRUCT_DESC: 24-inch CM pipe through the levee, 11.0 feet below the crown. Flap gate on the waterward end. Concrete "U" headwall on both ends. Grouted riprap apron on both ends. O&M Manual Sac 504, May 1965. FS Date: 3/11/2014

WS view: U type concrete headwall, flapgate, and CMP on levee slope. Looks clean and clear.

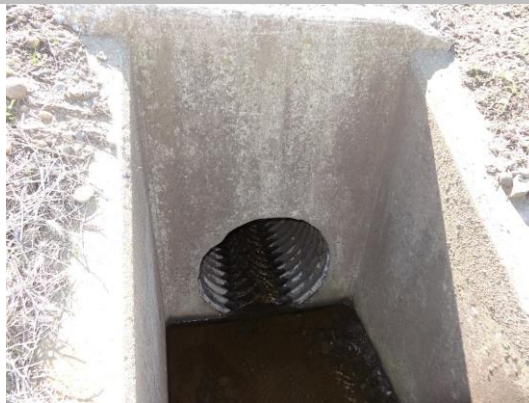
Photo 2 of 2 : UCIP_SP_2017_31899_58186.jpg

LS view: U type concrete headwall and CMP on levee slope. Looks clean and clear.

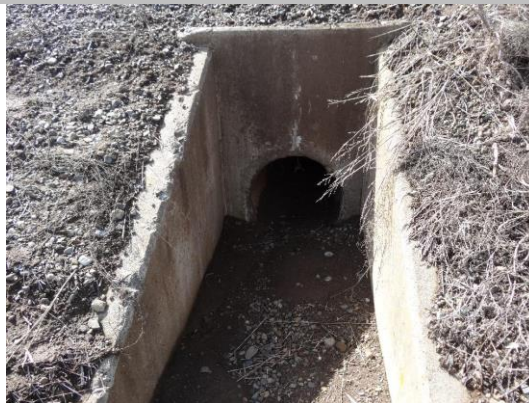
Photo 2 of 3 : UCIP_SP_2017_31901_58193.jpg

LM Start	3.08	Rating **	M	Issue No.	32 (cont)	
LM End	3.08	Issue Type +	Ma	Location *	LS	
Category	Supplemental			GPS Latitude/Longitude		
				Start	End	
Item	DWR UCIP LMA Responsibility			39.778016 °	39.778016 °	
				-121.854460 °	-121.854460 °	
DWR ID						
Comment Code						
Inspector Comment						
FS_ID:31901						
DS_ID:19269						
EP_NO: N/A						
Repair Type: Non-Urgent						
Crossing Status: Found						
UCIP Comments: Needs cleaning and clearing the culvert.						
FIELD_STRUCT_DESC: 24-inch CM pipe through the levee, 11.0 feet below the crown. Flap gate on the waterward end. Concrete "U" headwalls on both ends. Grouted riprap apron on the landward end. Grouted riprap spillway on the waterward end. O&M Manual Sac 504, May 1965.						
FS Date: 3/7/2014

LS view: U type concrete headwall and CMP on levee slope. Soil/mud on inlet box.

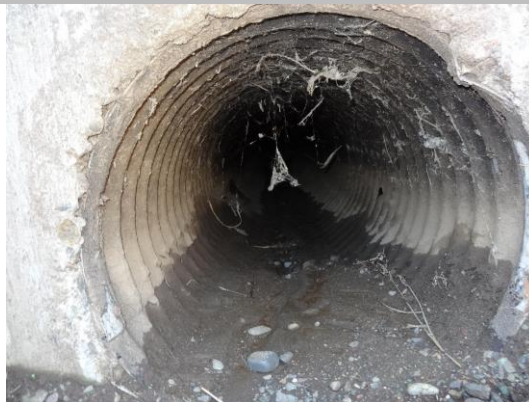
Photo 3 of 3 : UCIP_SP_2017_31901_58195.jpg

LS view: inside view of CMP on levee slope. Needs cleaning and clearing.

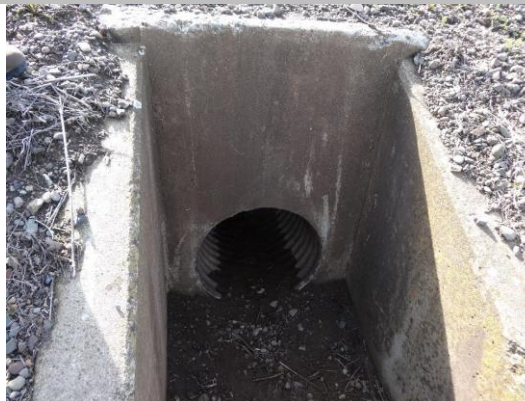
Photo 2 of 3 : UCIP_SP_2017_31864_58068.jpg

FS_ID:31864
DS_ID:19271
EP_NO: N/A
Repair Type: Non-Urgent
Crossing Status: Found
UCIP Comments: Needs cleaning and clearing the culvert.
FIELD_STRUCT_DESC: 24-inch CM pipe through the levee, 10.5 feet below the crown. Flap gate on the waterward end. Concrete "U" headwalls on both ends. Grouted riprap apron on the landward end. Grouted riprap spillway on the waterward end. O&M Manual Sac 504, May 1965.
FS Date: 3/7/2014

LS view: U type concrete headwall and CMP on levee slope. Soil/mud on inlet box.

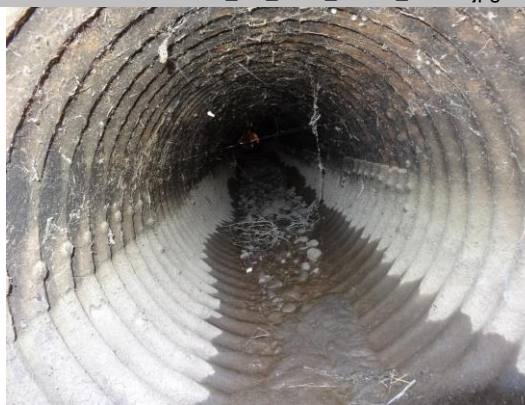
Photo 3 of 3 : UCIP_SP_2017_31864_58067.jpg

LS view: inside view of CMP on levee slope. Needs cleaning and clearing.

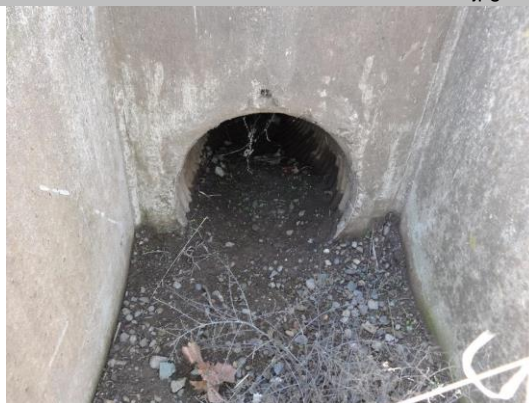
Photo 2 of 3 : UCIP_SP_2017_31856_58052.jpg

LS view: U type concrete headwall and CMP on levee slope. Soil/mud on inlet box.

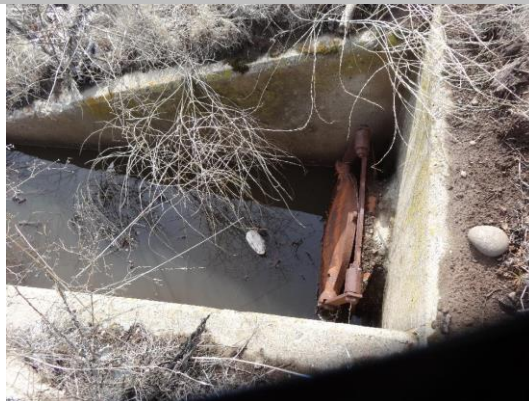
Photo 1 of 2 : UCIP_SP_2017_32125_58629.jpg

LM Start	3.68	Rating **	M	Issue No.	37
LM End	3.68	Issue Type +	Ma	Location *	LS
Category	Supplemental			GPS Latitude/Longitude	
				Start	End
Item	DWR UCIP LMA Responsibility			39.777662 °	39.777662 °
				-121.843489 °	-121.843489 °
DWR ID					
Comment Code					
Inspector Comment					
FS_ID:32125					
DS_ID:19275					
EP_NO: N/A					
Repair Type: Non-Urgent					
Crossing Status: Found					
UCIP Comments: The culvert was working during the field visit.Needs cleaning and clearing on both ends of the pipe.					
FIELD_STRUCT_DESC: 24-inch CM pipe through the levee, 7.5 feet below the crown. Flap gate on the waterward end. Concrete "U" headwalls on both ends. Grouted riprap apron on the landward end. Grouted riprap spillway on the waterward end. O&M Manual Sac 504, May 1965.					
FS Date: 3/4/2014

WS view: U type concrete headwall, pipe, and flapgate on levee slope. Soil/mud on outlet box. Vegetation debris blocking outlet box.

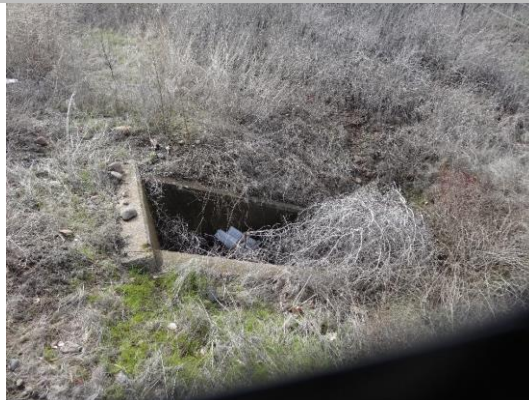
Photo 2 of 2 : UCIP_SP_2017_32125_58628.jpg

LS view: U type concrete headwall and pipe on levee slope. Soil/mud on inlet box. Vegetation debris blocking inlet box.

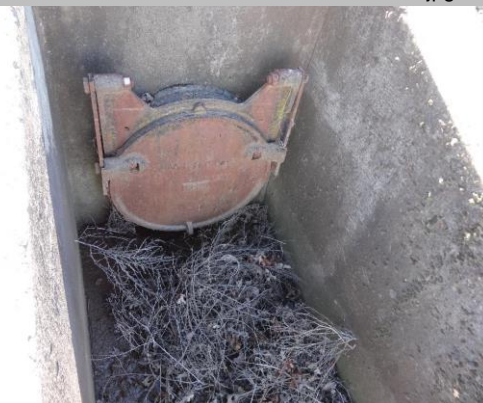
Photo 2 of 3 : UCIP_SP_2017_32026_58519.jpg

WS view: U type concrete headwall and CMP on levee slope. Mud and vegetation debris on outlet box.

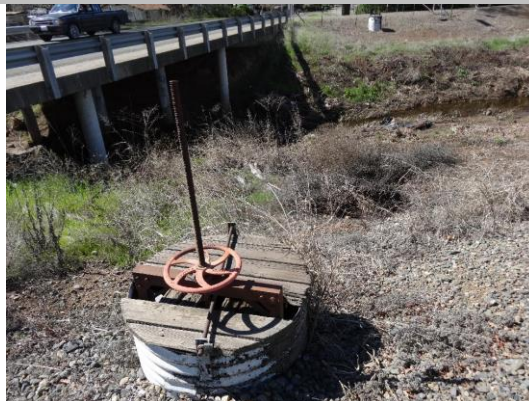
Photo 1 of 3 : UCIP_SP_2017_32025_58512.jpg

WS view: slide gate in CMP riser on waterside shoulder.

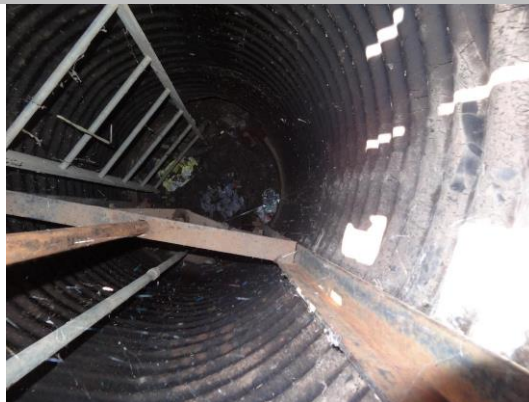
Photo 2 of 3 : UCIP_SP_2017_32025_58511.jpg

WS view: inside view of slide gate in CMP riser on waterside shoulder.
Debris trapped in the riser.

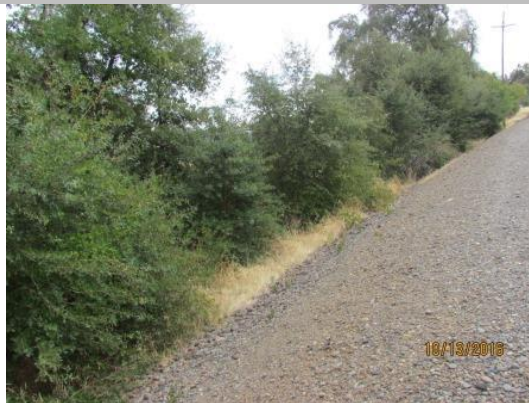
Photo 1 of 1 : SP_2017_NA0003_68_21_20170315_00007.jpg

LM Start	0.35	Rating **	M	Issue No.	21
LM End	0.39	Issue Type +	Ma	Location *	LS
Category	Earthen Levee			GPS Latitude/Longitude	
				Start	End
Item	Trim / Thin Trees			39.775672 °	39.775220 °
				-121.850301 °	-121.849805 °
DWR ID	DWR_NA0003_04_f_2016_21				
Comment Code					
T2 : Thin trees to allow visibility of the ground and room to flood fight.					
Inspector Comment

View of the overgrown trees along the landside toe.

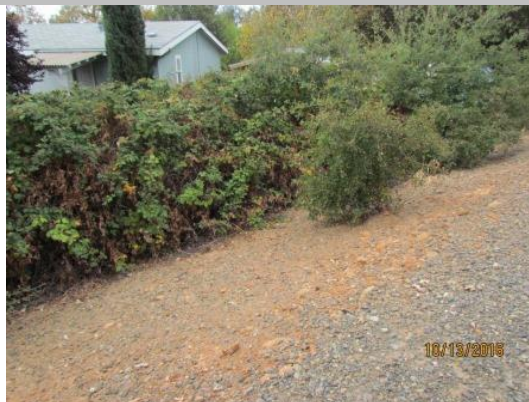
Photo 1 of 1 : SP_2017_NA0003_68_22_20170315_00008.jpg

LM Start	0.90	Rating **	M	Issue No.	22
LM End	0.90	Issue Type +	Ma	Location *	LS
Category	Earthen Levee			GPS Latitude/Longitude	
				Start	End
Item	Vegetation			39.775486 °	39.775486 °
				-121.850606 °	-121.850606 °
DWR ID	DWR_NA0003_04_f_2016_22				
Comment Code					
V2 : Remove the wild growth other than native grasses from the levee slopes.					
Inspector Comment

View of the blackberries blocking visibility and access.

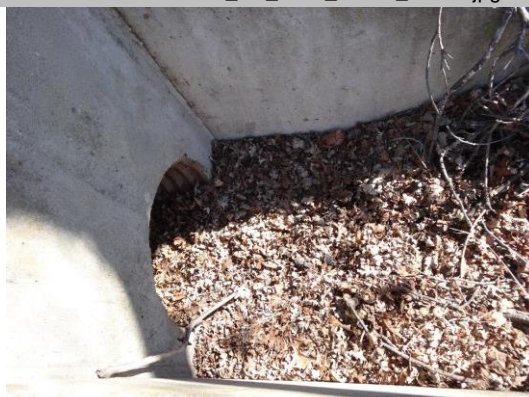
Photo 2 of 2 : UCIP_SP_2017_32143_58640.jpg

LS view: U type concrete headwall and CMP on levee slope. Vegetation and mud on inlet box.

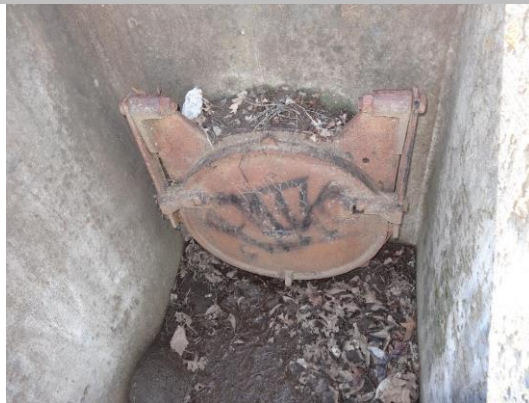
Photo 1 of 3 : UCIP_SP_2017_31963_58384.jpg

FS_ID:31963
DS_ID:19289
EP_NO: N/A
Repair Type: Non-Urgent
Crossing Status: Found
UCIP Comments: Needs cleaning and clearing the culvert.
FIELD_STRUCT_DESC: 24-inch CM pipe through the levee, 11.0 feet below the flap gate on the waterward end. Concrete "U" headwalls on both ends. Grouted riprap apron on the landward end. Grouted riprap spillway on the waterward end. O&M Manual Sac 504, May 1965.
FS Date: 3/7/2014

WS view: U type concrete headwall and CMP on levee slope. Vegetation debris and mud on outlet box. Needs cleaning and clearing.

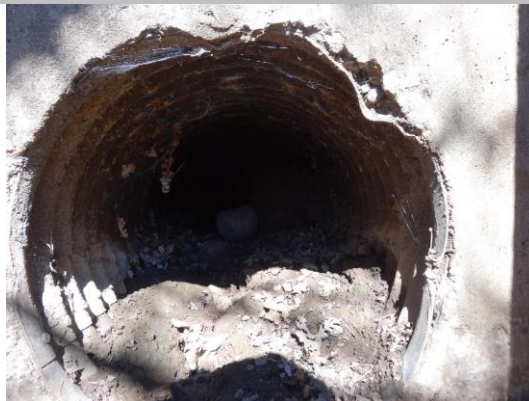
Photo 3 of 3 : UCIP_SP_2017_31963_58385.jpg

LS view: inside view of CMP on levee slope. Needs cleaning and clearing.

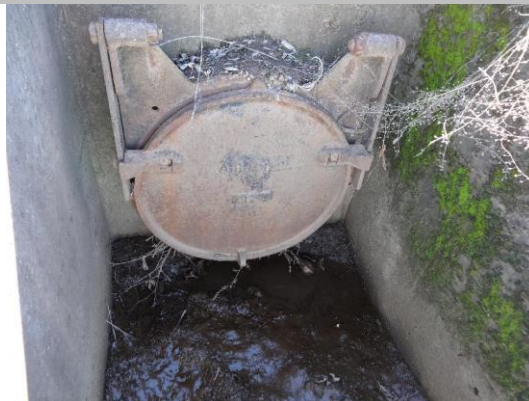
Photo 1 of 2 : UCIP_SP_2017_31964_58389.jpg

WS view: U type concrete headwall and CMP on levee slope. Vegetation debris and mud in outlet box. Needs cleaning and clearing.

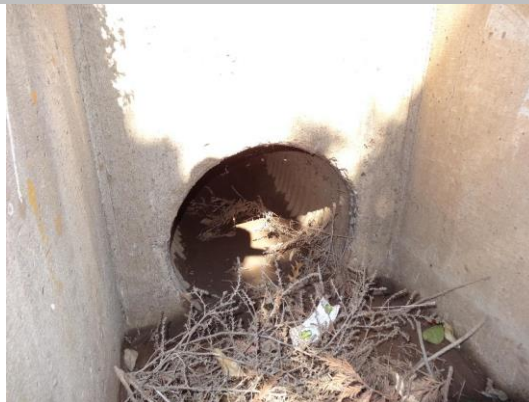
Photo 2 of 2 : UCIP_SP_2017_31964_58388.jpg

LS view: U type concrete headwall and CMP on levee slope. Vegetation debris and mud in inlet box.

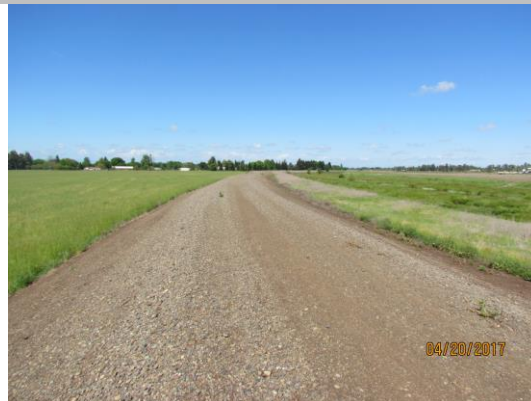
Photo 1 of 1 : SP_2017_NA0003_68_16_20170426_00038.jpg

LM Start	1.56	Rating **	A	Issue No.	16
LM End	1.56	Issue Type +	Ma	Location *	LS
Category	Earthen Levee			GPS Latitude/Longitude	
				Start	End
Item	Vegetation			39.778610 °	39.778610 °
				-121.861735 °	-121.861735 °
DWR ID	DWR_NA0003_04_s_2017_16				
Comment Code					
V1 : Control annual grass and weeds on the levee slopes and easements.					
Inspector Comment

View of no vegetation on both slopes.

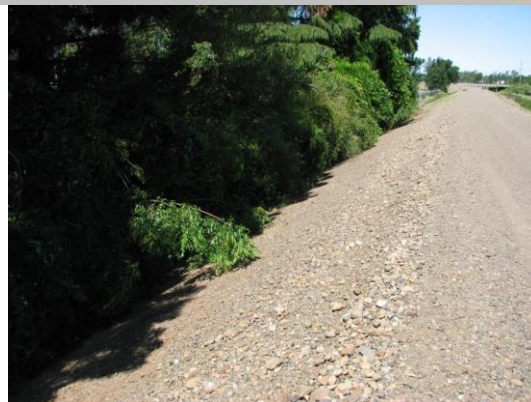
Photo 1 of 1 : SP_2017_NA0003_68_18_20170315_00005.jpg

LM Start	2.04	Rating **	U	Issue No.	18
LM End	2.08	Issue Type +	Ma	Location *	LS
Category	Earthen Levee			GPS Latitude/Longitude	
				Start	End
Item	Trim / Thin Trees			39.781669 °	39.782025 °
				-121.869804 °	-121.870252 °
DWR ID	DWR_NA0003_04_s_2016_18				
Comment Code					
T2 : Thin trees to allow visibility of the ground and room to flood fight.					
Inspector Comment					
Trees and shrubbery obscure visibility on landside toe hinge point.

View of the vegetation on fence at landside toe.

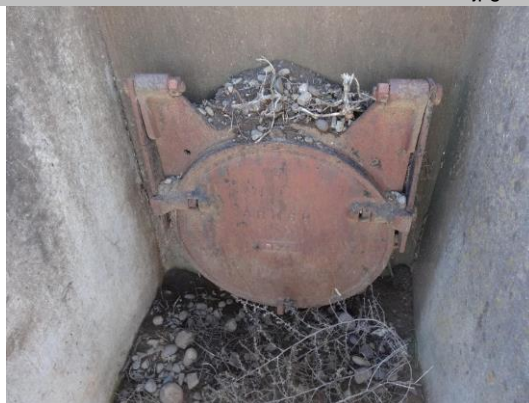
Photo 1 of 3 : UCIP_SP_2017_31965_58395.jpg

FS_ID:31965
DS_ID:19291
EP_NO: N/A
Repair Type: Non-Urgent
Crossing Status: Found
UCIP Comments: Needs cleaning and clearing the culvert.
FIELD_STRUCT_DESC: 24-inch CM pipe through the levee, 11.0 feet below the crown. Flap gate on the waterward end. Concrete "U" headwall on both ends. Grouted riprap apron on the landward end. Grouted riprap spillway on the waterward end. O&M Manual Sac 504, May 1965.
FS Date: 3/7/2014

WS view: U type concrete headwall and CMP on levee slope. Vegetation debris and mud in outlet box. Needs cleaning and clearing.

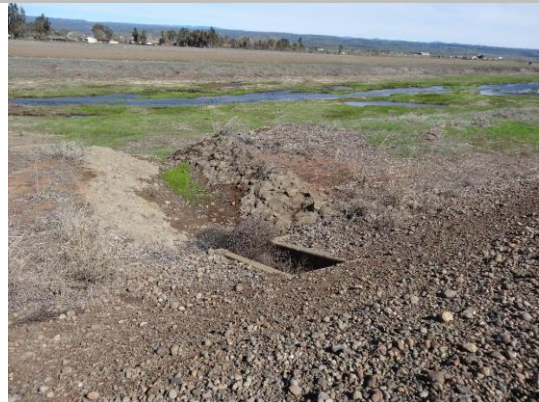
Photo 1 of 3 : UCIP_SP_2017_31966_58401.jpg

WS view: U type concrete headwall and grouted riprap spillway on levee slope.

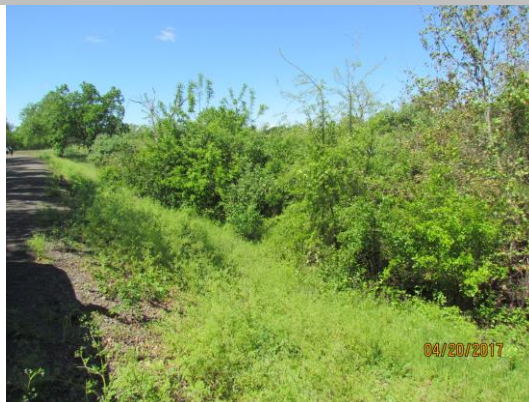
Photo 1 of 1 : SP_2017_NA0003_69_9_20170426_00012.jpg

LM Start	0.33	Rating **	M	Issue No.	9
LM End	0.33	Issue Type +	Ma	Location *	WS
Category	Earthen Levee			GPS Latitude/Longitude	
				Start	End
Item	Vegetation			39.761642 °	39.761642 °
				-121.795008 °	-121.795008 °
DWR ID	DWR_NA0003_05_s_2017_9				
Comment Code					
V2 : Remove the wild growth other than native grasses from the levee slopes.					
Inspector Comment

View of the vegetation along the waterside slope and toe.

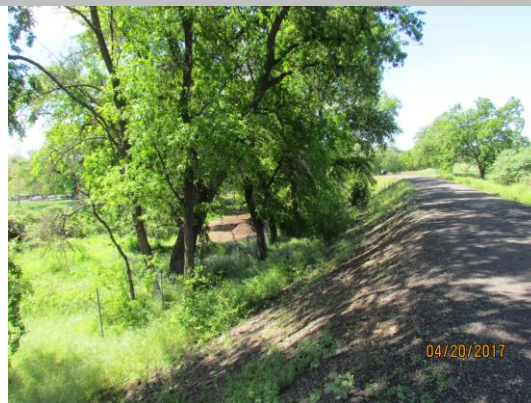
Photo 1 of 2 : SP_2017_NA0003_69_3_20170426_00010.jpg

LM Start	0.34	Rating **	M	Issue No.	3
LM End	0.42	Issue Type +	Ma	Location *	LS
Category	Earthen Levee			GPS Latitude/Longitude	
				Start	End
Item	Vegetation			39.761633 °	39.761117 °
				-121.795155 °	-121.796464 °
DWR ID	DWR_NA0003_05_f_2013_3				
Comment Code					
V2 : Remove the wild growth other than native grasses from the levee slopes.					
Inspector Comment

View of the vegetation along the landside slope and toe.

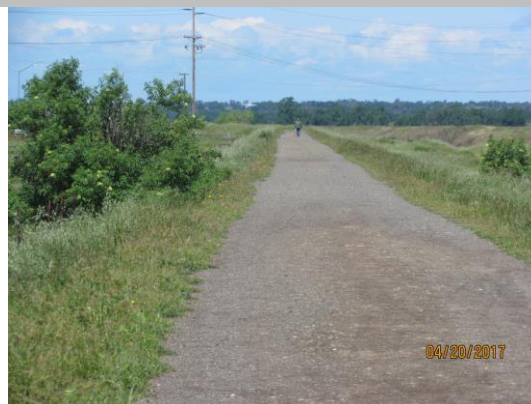
Photo 1 of 1 : SP_2017_NA0003_69_14_20170426_00013.jpg

LM Start	0.84	Rating **	A	Issue No.	14
LM End	0.84	Issue Type +	Ma	Location *	LS
Category	Earthen Levee			GPS Latitude/Longitude	
				Start	End
Item	Vegetation			39.763700 °	39.763700 °
				-121.802752 °	-121.802752 °
DWR ID	DWR_NA0003_05_s_2017_14				
Comment Code					
V1 : Control annual grass and weeds on the levee slopes and easements.					
Inspector Comment

View of the native grasses on both slopes.
